K M LIECHTI ET AL. SEP. 82 AFWAL-TR-82-4085

SEM/TEM FRACTOGRAPHY OF COMPOSITE MATERIALS

General Dynamics
Fort Worth Division
P.O. Box 748
Fort Worth, Texas 76101

SEPTEMBER 1982

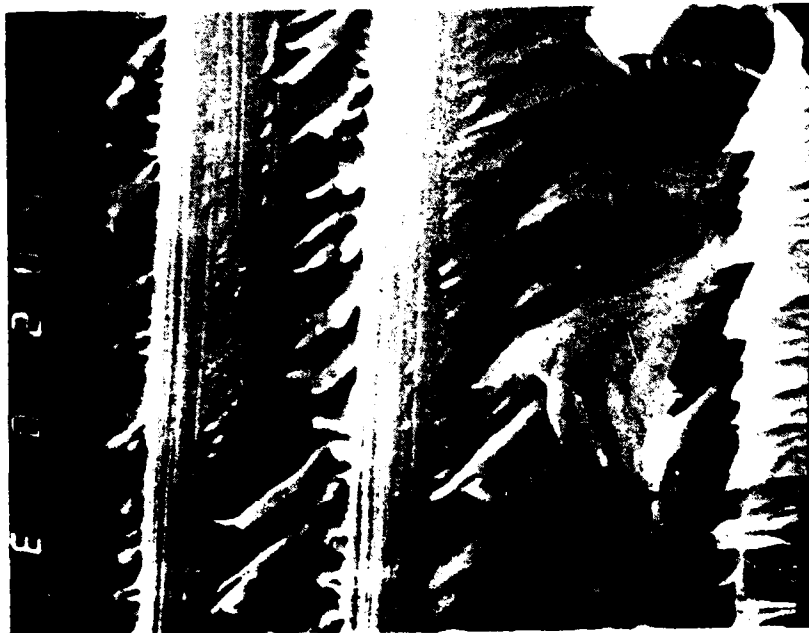
Figure 30f Hackles on 90° Fracture Surface, 5000x

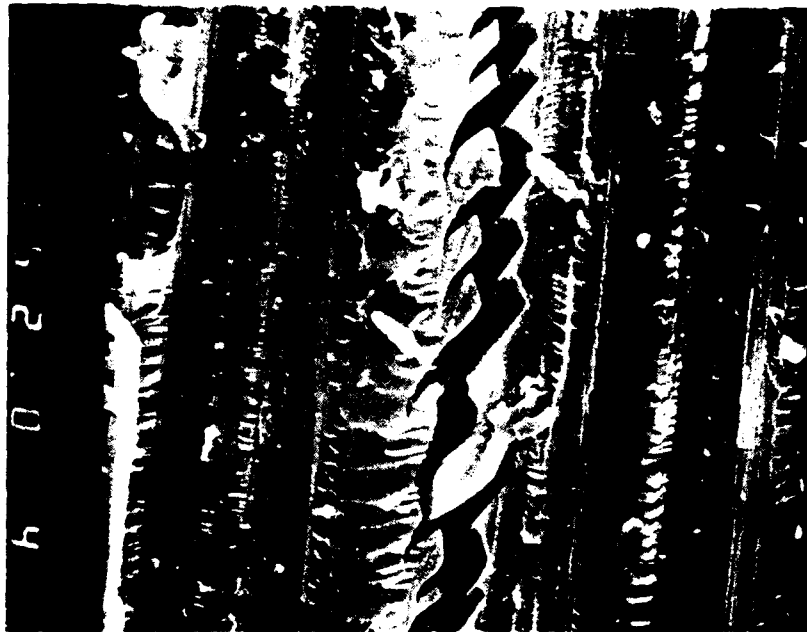
Figure 30g Edge View of Transverse Crack, 1500x

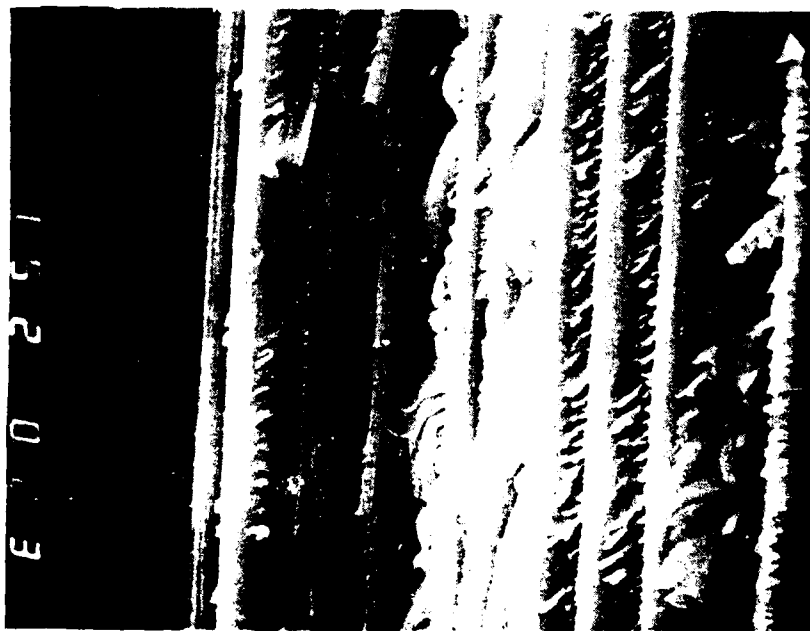
Figure 30h Mode I - Mode II Transition, 1500x

compressive side. Figure 30d shows a photomicrograph of the granulation believed to have been formed by abrasion between the surfaces. Consequently, the features of the fracture surface were obliterated by secondary damage formations. Consequently, emphasis was placed upon the right side where the features remained free of debris. In Figure 30e (5000X), the apex is to the right and the tensile face is to the left. The cleavage planes are relatively smooth and the river markings imply that the crack direction was from left to right (i.e., originated at the edge and propagated toward the apex). Evidence of shear failure is also evident on this surface. Figures 30f,g are an example of the hackle patterns typical of shear failure. Also in Figure 30g a crack extending into the surface is evident. In summation, this failure surface is mixed mode, evidence of both Mode I and II are found. Figure 30h is an example of a transition region between Mode I left and Mode II right.
